## Research Paper

# Seismic vulnerability analysis and finite element modeling of San Guillermo Parish: A historical coral stone church – in Catmon, Cebu, Philippines

## ABSTRACT

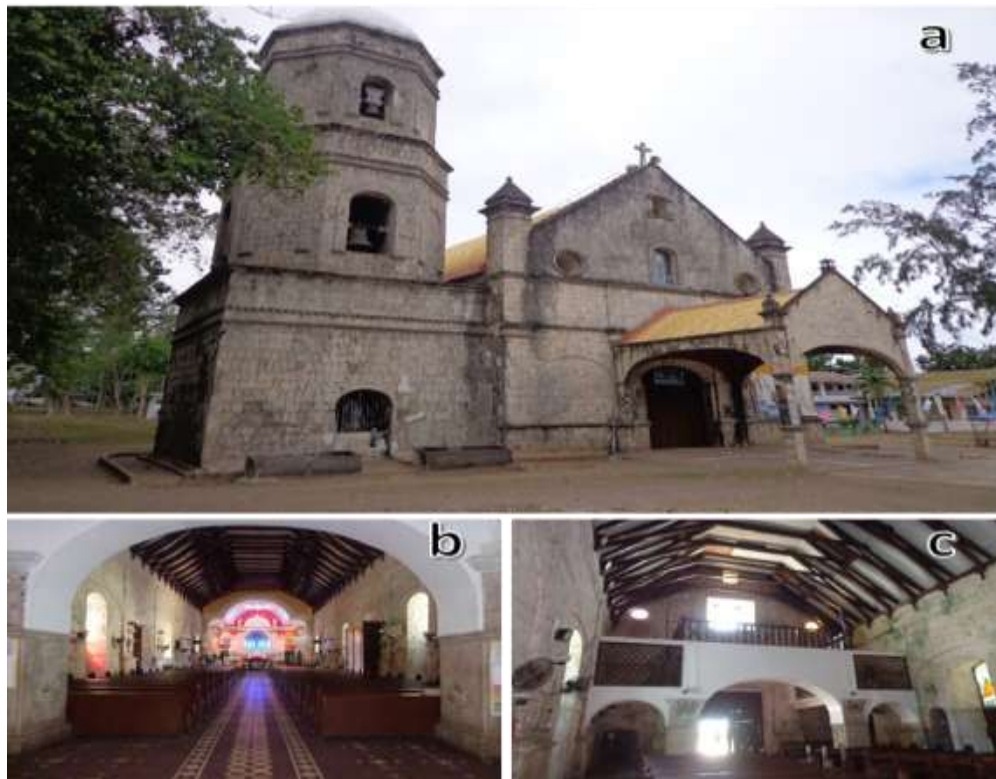
**Figure 2:** San Guillermo church (a) exterior (b) interior facing altar and (c) facing main entrance.

Parish in Catmon, Cebu, Philippines (Figures 1 and 2). The church is around 180 years old as of the present time and is considered as one of the heritage sites in Cebu. It experienced the tremor created by the Bohol 2013 earthquake, and as reported by the residents, a number of stone blocks fell off from the structure during the seismic activity making it worthy for an investigation. It is a must to know the current status of its structural integrity and serviceability for the locality's safety and historical preservation.

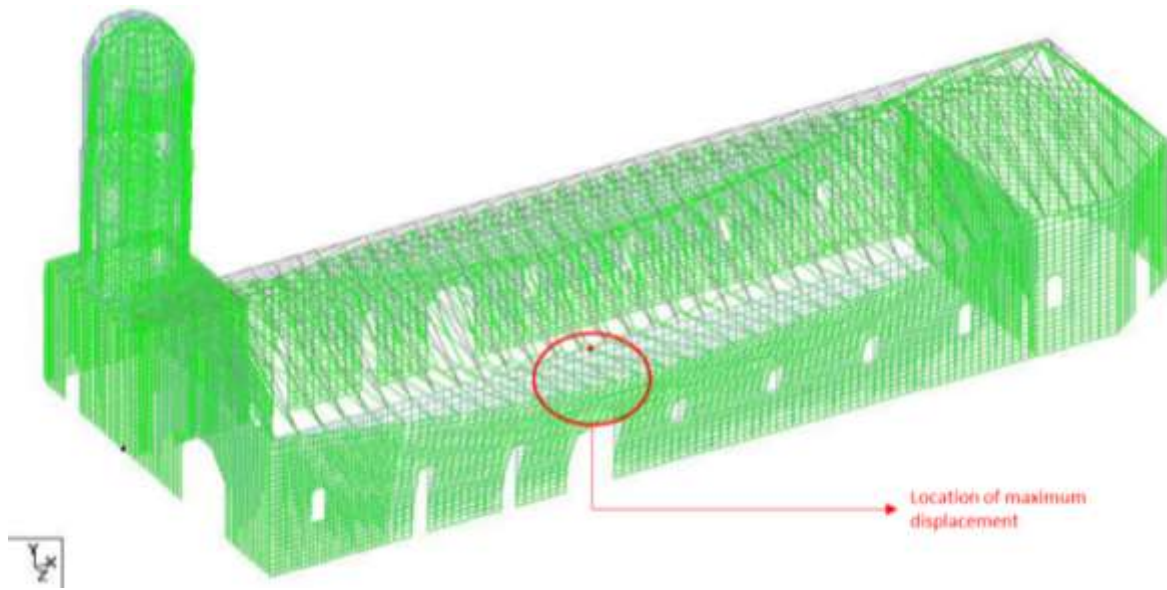
**Figure 6:** Maximum registered displacement location.

(Figure 6) that occurred was 71.576 mm located at the topmost portion of the nave wall directly above the door opening, right of the church. The dominant load type is the combination of service dead, live and earthquake load. Table 2 summarizes the displacements experienced by the structure during the simulation including the specific

The maximum drift ratio, defined as the drift to height of the church, is about 0.89%, which is less than the allowed drift ratio of 1% prescribed by FEMA 356 structural performance level (life safety) (FEMA, Prestandard and commentary for the seismic rehabilitation of buildings, 2000) which was also adopted in the study “Numerical modeling and experimental investigation of masonry structures” (Zeng, 2010). These observations indicate that the deformation of San Guillermo church is acceptable when subjected to a design seismic in relation to the tremor it experienced during the massive earthquake with epicenter at Bohol last October, 2013. There were no visible URM displacements observed during the site visit after the catastrophe, the structure remains firm and stable in structural engineering’s perspective.

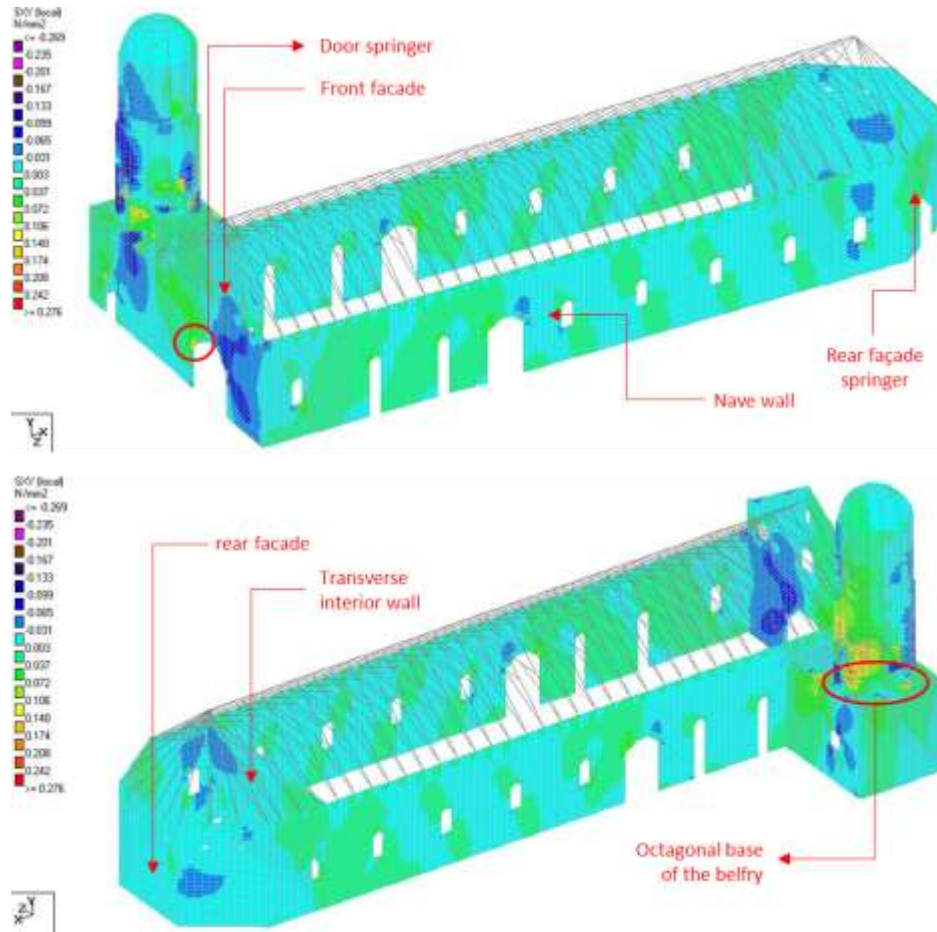
Figure 7: Shear stress in the local XY plane by service load combination DL+LL+Ez/1.4.

In Figure 7 the maximum resulting shear stress developed in the springer of the door openings at rear and front façade are 0.162 MPa. The octagonal base at the second level of the belfry has 0.19 MPa exceeding UCBC and UBC shear values. The front façade had shear value not greater than 0.04 MPa. ACI and ABK shear strength criterion (ultimate) with allowable values of 0.36 and 0.58 MPa were not exceeded, respectively. Only the value of UCBC and UBC were overshadowed during the response spectrum analysis.

Table 4 summarizes the critical shear stress experienced by San Guillermo church. From the aforementioned observations listed, the shear stress contour suggested that the majority of the church wall should not experience extent of damage considering the allowable shear strength criterion of ABK Methodology and ACI 530-88. Critical locations for shear actions were known from the contour plots emphasized where the stress value exceeds the UCBC and UBC criteria. These locations are the springer of the main entrance and the second level of the bell tower. The propagation of damages can safely be concluded to initiate from this vulnerable portions of the church in terms of shear stresses. Critical portions for shear shown may also exhibit poor bonding between stones since shear stress originates mostly within the gaps filled with lime mortar in most URM structures.

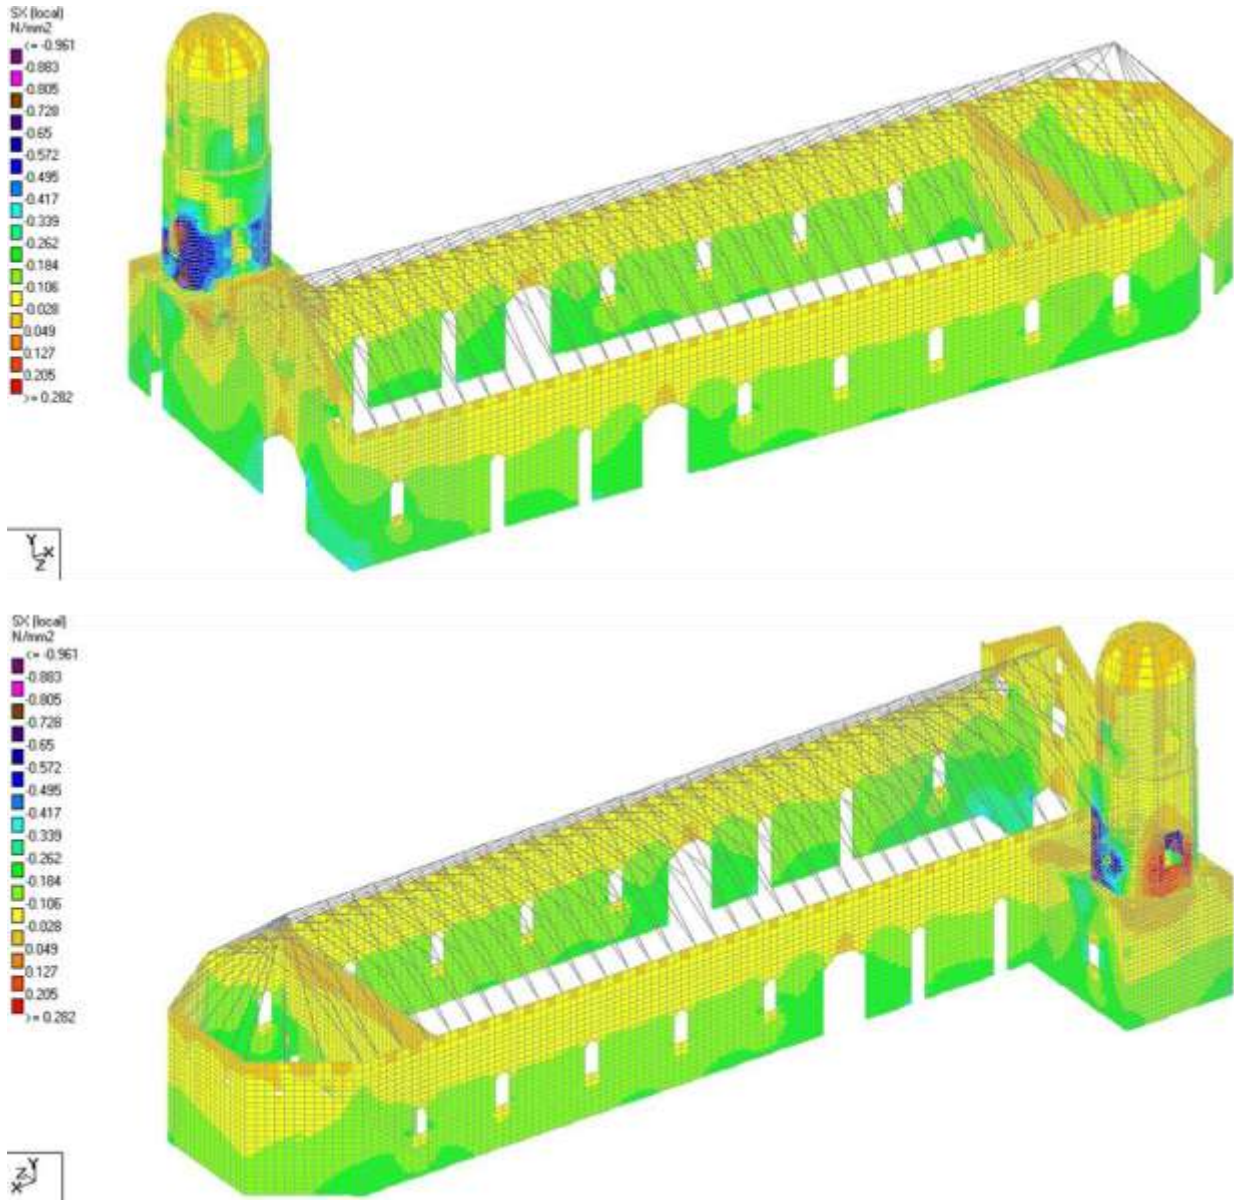
**Figure 8:** Axial stress in local X by service load combination DL+LL+Ez/1.4.

The stress contour regions for the normal stresses were defined to highlight tensile and compressive stress states. In lieu of provisions from the UCBC and the ABK methodology the ACI 530-88 and the UBC provisions were considered. Figure 8 shows the axial stress contours in the local X direction. Contour values were selected, negative ones represent compression while positive values are tensile stresses. The UBC code specifies an allowable tensile stress of 0.25 MPa for flexural tension normal to the head joints while ACI 530-88 does not permit any tension to

Compression dominates all throughout the URM church when DL+LL combination was considered. Maximum compressive stress of 0.602 MPa was registered at the front of the second level of belfry. Axial stress in local X direction showcases compression of 0.143 MPa at the rear façade door opening springer. For service load combinations DL+LL+Ex/1.4 and DL+LL+Ez/1.4) evident propagation of compressive stresses were observed at the second level of the bell tower with magnitude of not more than 0.909 MPa while its side was in tension of 0.277 MPa. The remaining walls were in compression of not greater than 0.50 MPa.

Tensile stress of 0.036 MPa was pin pointed at the rear façade door opening springer.

In light of the earlier observations, tensile stresses were critical when compared to the prescribed values of 0 and 0.25 MPa from ACI and UBC, respectively; these results strongly agrees to the claim that most URM structures are susceptible to tension though for this specific structure only few portion experienced this type of stress. On the other hand, most of the URM walls were subjected to compressive stress and its magnitude were lower than the allowable compression for unreinforced masonry prescribed by the UBC and ACI 530-88 code. These structural components in compression were expected to present little or no damage under out-of-plane stresses. Table 5 sets out the summary
